UNDERWATER BRIDGE INSPECTION REPORT

STRUCTURE NO. 55031

SOUTH BRANCH MIDDLE FORK ZUMBRO RIVER

DISTRICT 6 – OLMSTEAD COUNTY

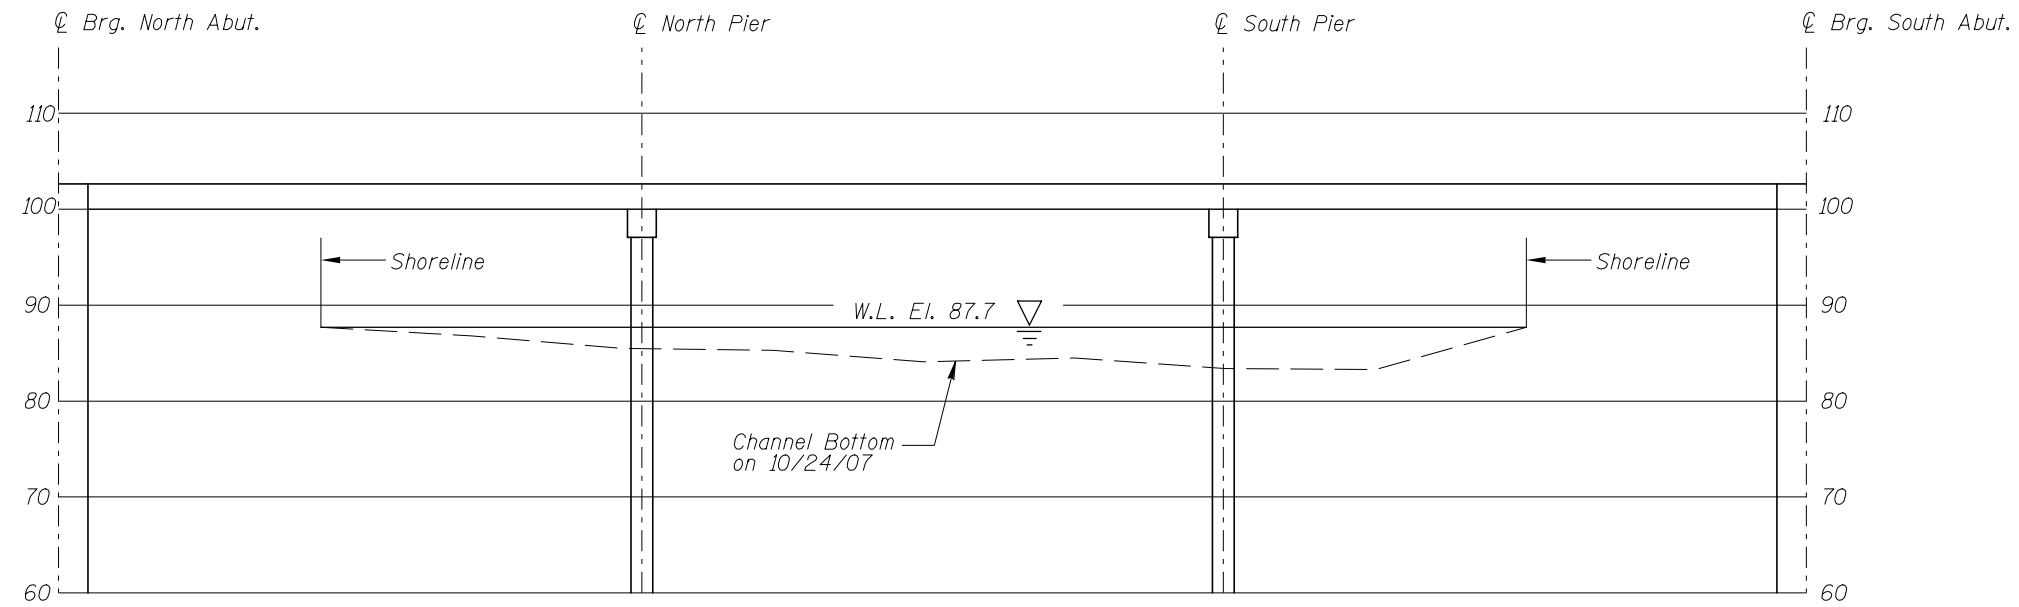
UPSTREAM FASCIA PROFILE

- 1 A scour depression measuring 4 feet radially by 2 feet deep was observed at the upstream pile of the south pier.
- 2 Steel piles at both piers show no coating failure or corrosion below water; however, from the pile cap down 5 feet, there was up to 25 percent coating failure and minor surface corrosion.
- 3 The channel bottom consisted of silty sand with 1 foot maximum probe rod penetration.
- 4 A heavy accumulation of timber debris consisting of 1.5 feet diameter and smaller logs and branches was observed at the north side of the south pier extending from the channel bottom to 5 feet above the waterline.
- 5 A heavy accumulation of timber debris consisting of 2 feet diameter and smaller logs and branches was observed at the north side of the north pier extending from the channel bottom to 5 feet above the waterline.
